Terrain Penetrations of Part 77 Surfaces

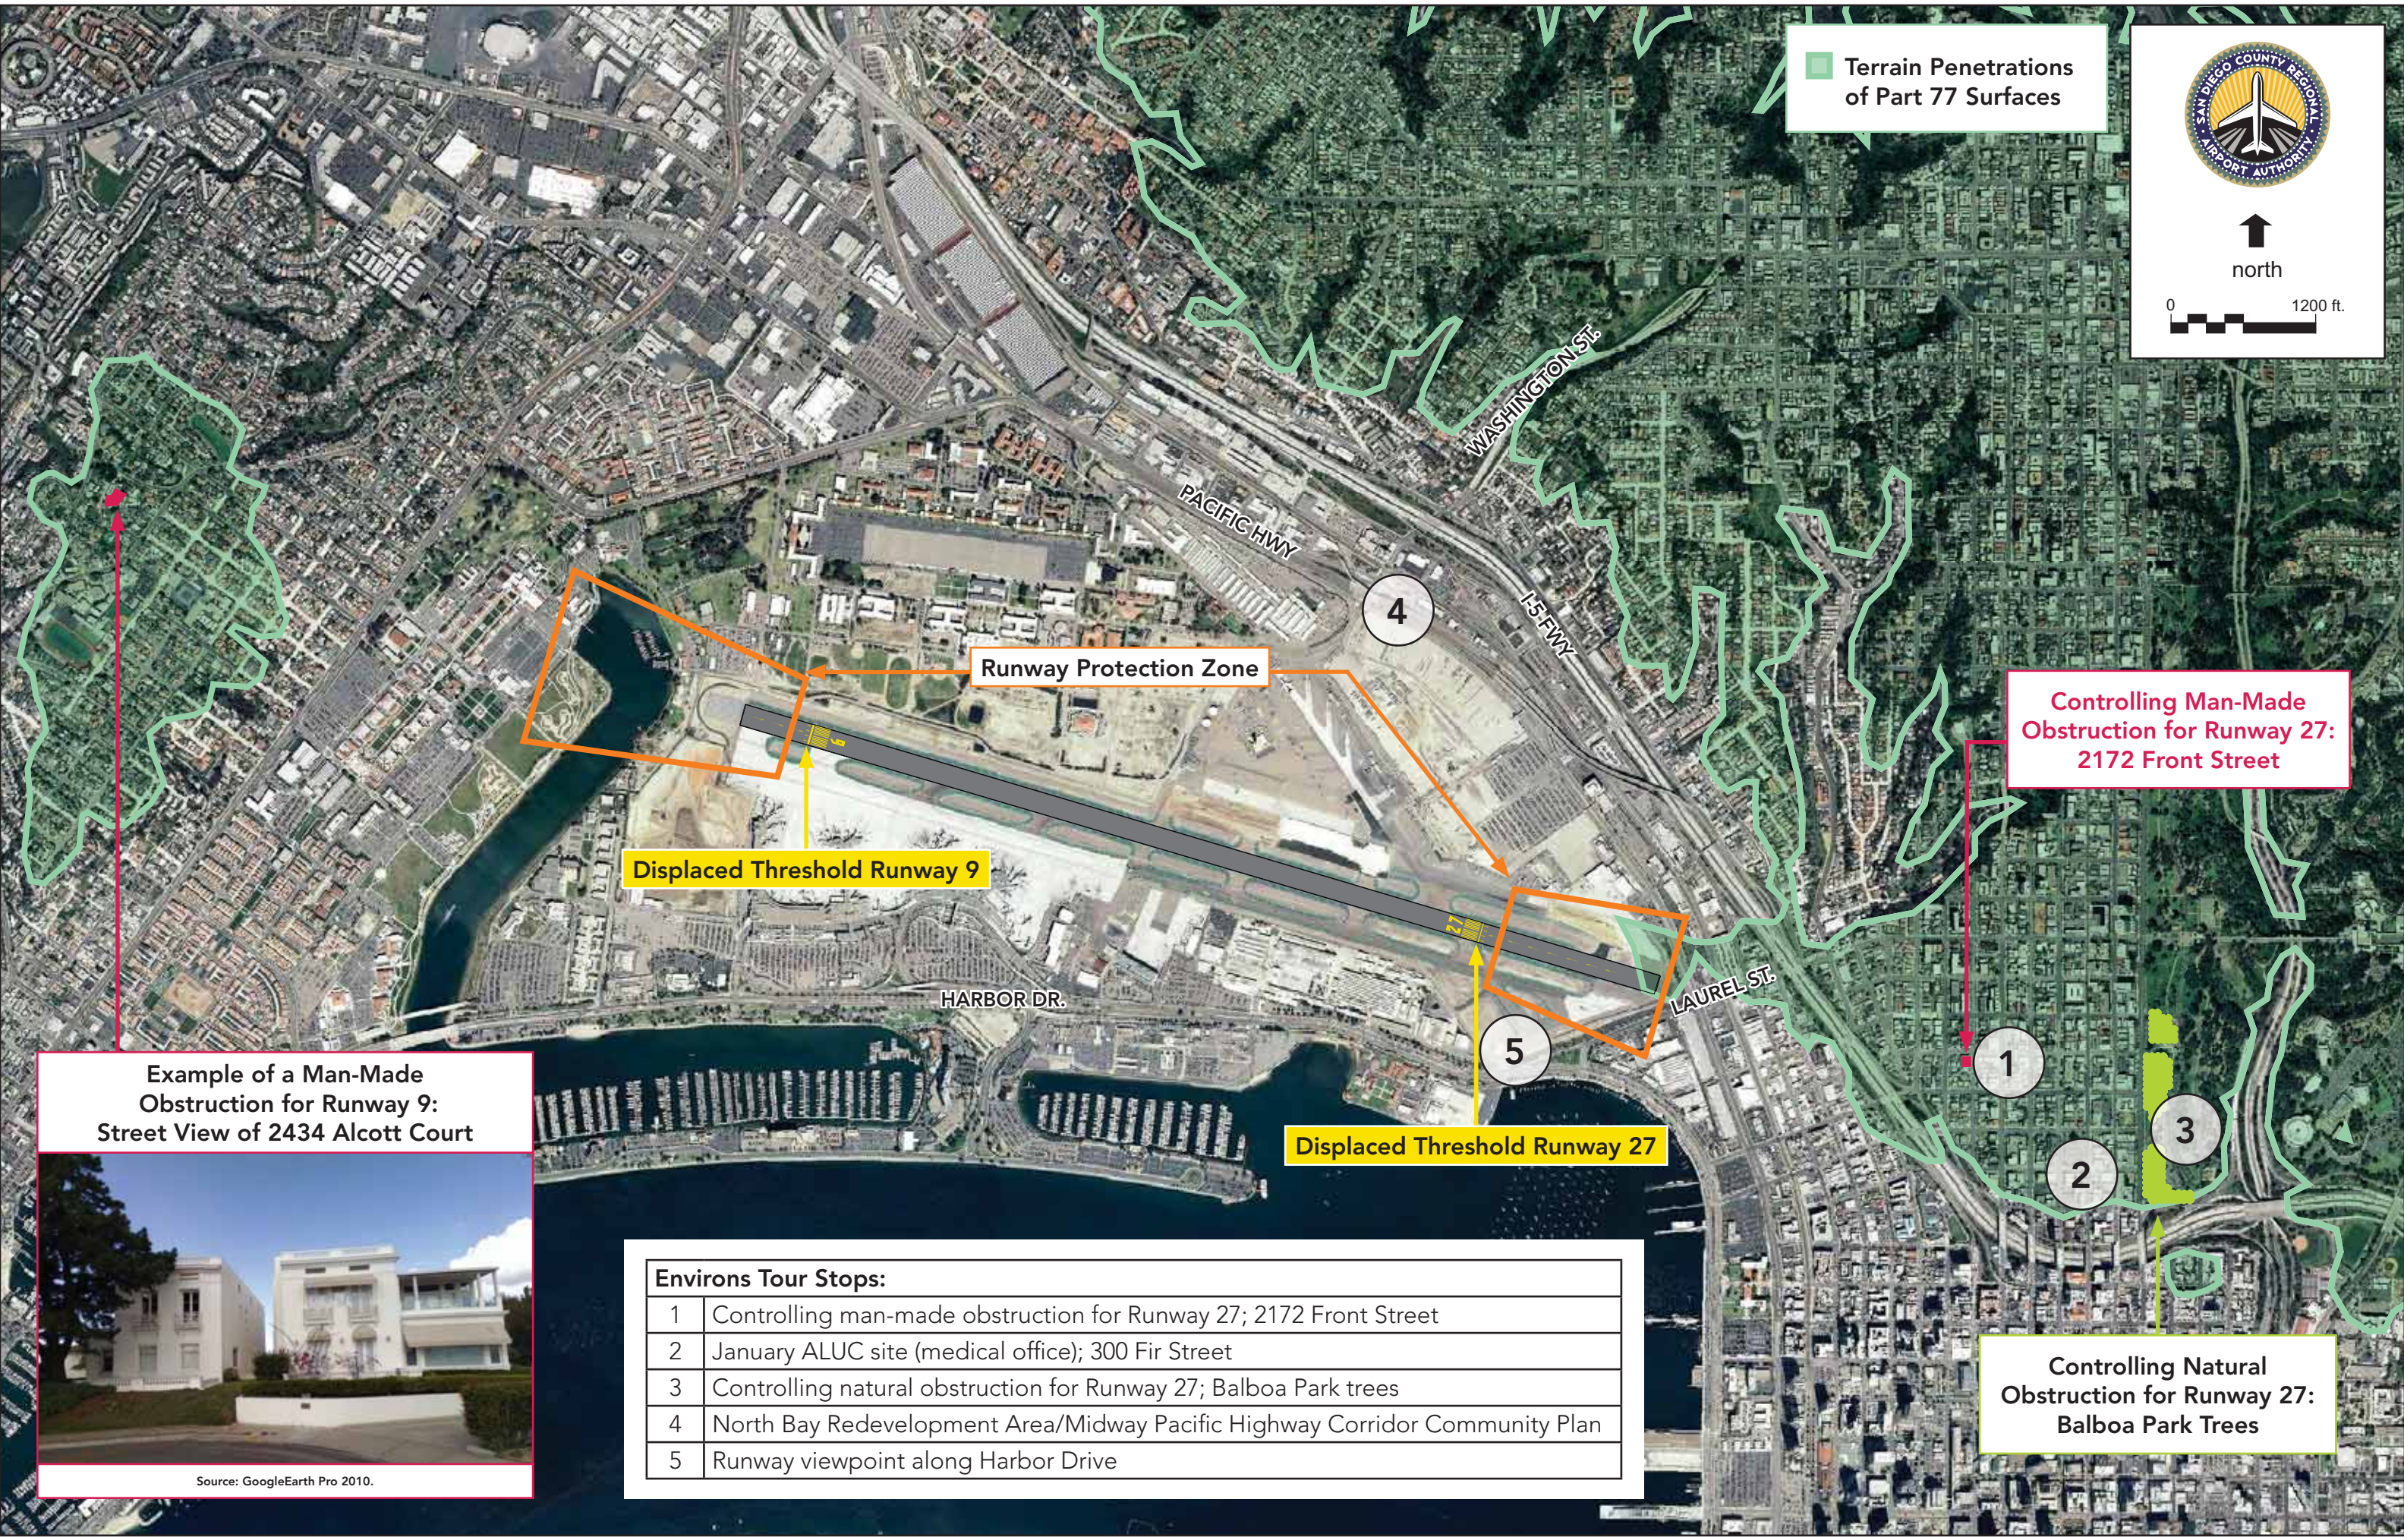
Controlling Man-Made Obstruction for Runway 27: 2172 Front Street

Controlling Natural Obstruction for Runway 27: Balboa Park Trees

Displaced Threshold Runway 9

Displaced Threshold Runway 27

Runway Protection Zone

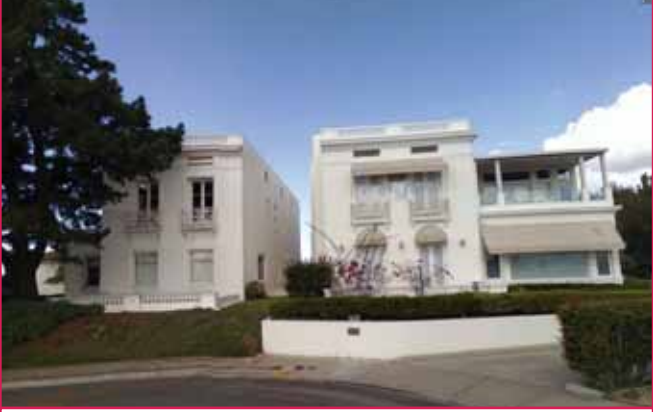
Example of a Man-Made Obstruction for Runway 9: Street View of 2434 Alcott Court
